**MILLIKEN CLEAN COAL TECHNOLOGY  
DEMONSTRATION PROJECT**

**HEAT PIPE PERFORMANCE – FINAL REPORT**

Prepared by

CONSOL Inc.  
Research and Development  
4000 Brownsville Road  
Library, Pennsylvania 15129-9566

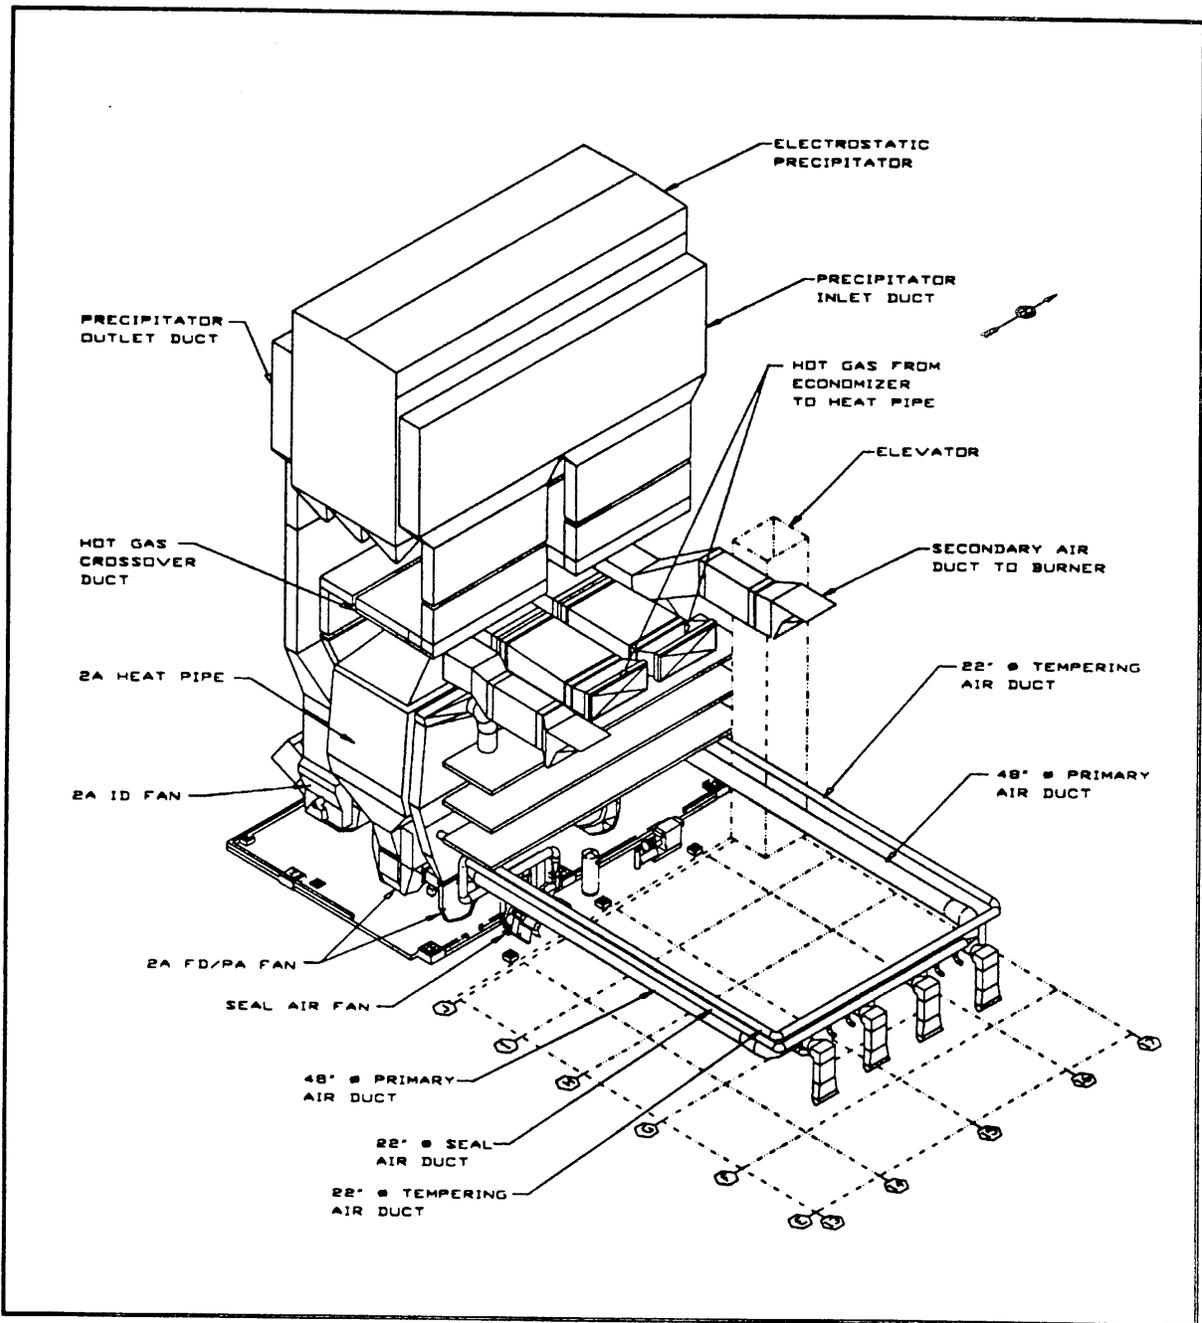
Figure 16. Isometric view of heat pipe air heater and ductwork.

Figure 15 is a northward facing view of the unit showing the primary and secondary air duct system. The view shows the PA and FD fans and the common motor. Placing the PA and FD fans directly below the heat pipes allows use of short expanding ducts between the fan discharges and the heat pipe connection flanges. An isometric view of the system is presented in Figure 16.

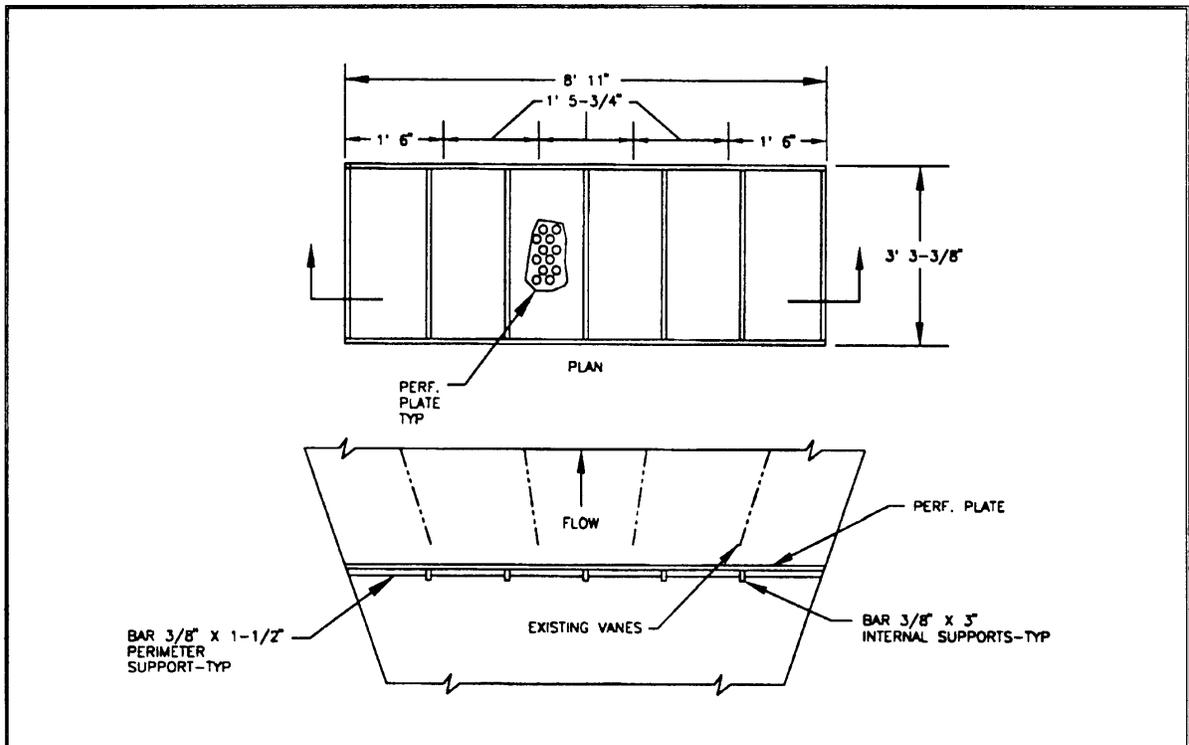
Figure 17. Perforated plate installation in the primary air fan discharge duct.

To help flatten the fan velocity profiles, ABB API recommended installation of perforated plates at the primary air and secondary air (FD) fan outlets. The original heat pipe flow modeling study recommended similar distribution plates (see Appendix C). Figures 17 and 18 show how the perforated plates were installed. The plates were made of 10 gage carbon steel with 63 percent open area.

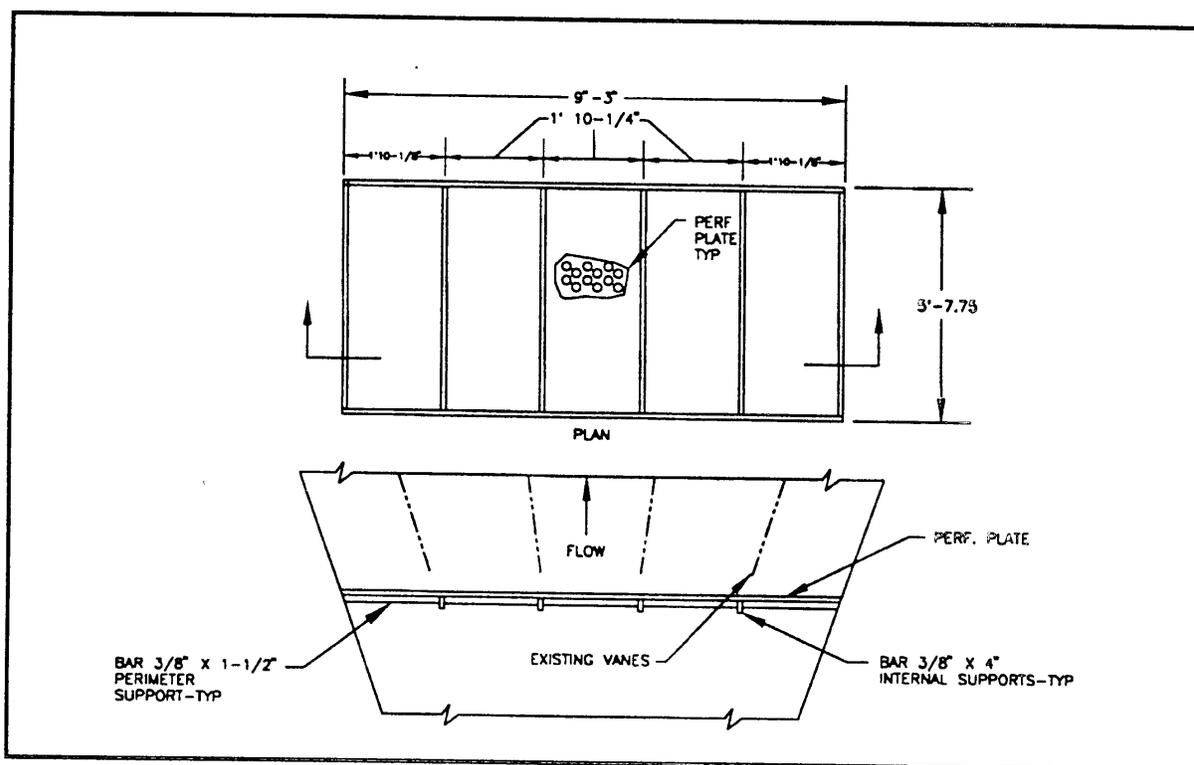
**Figure 18.** Perforated plate installation in the FD fan discharge duct.

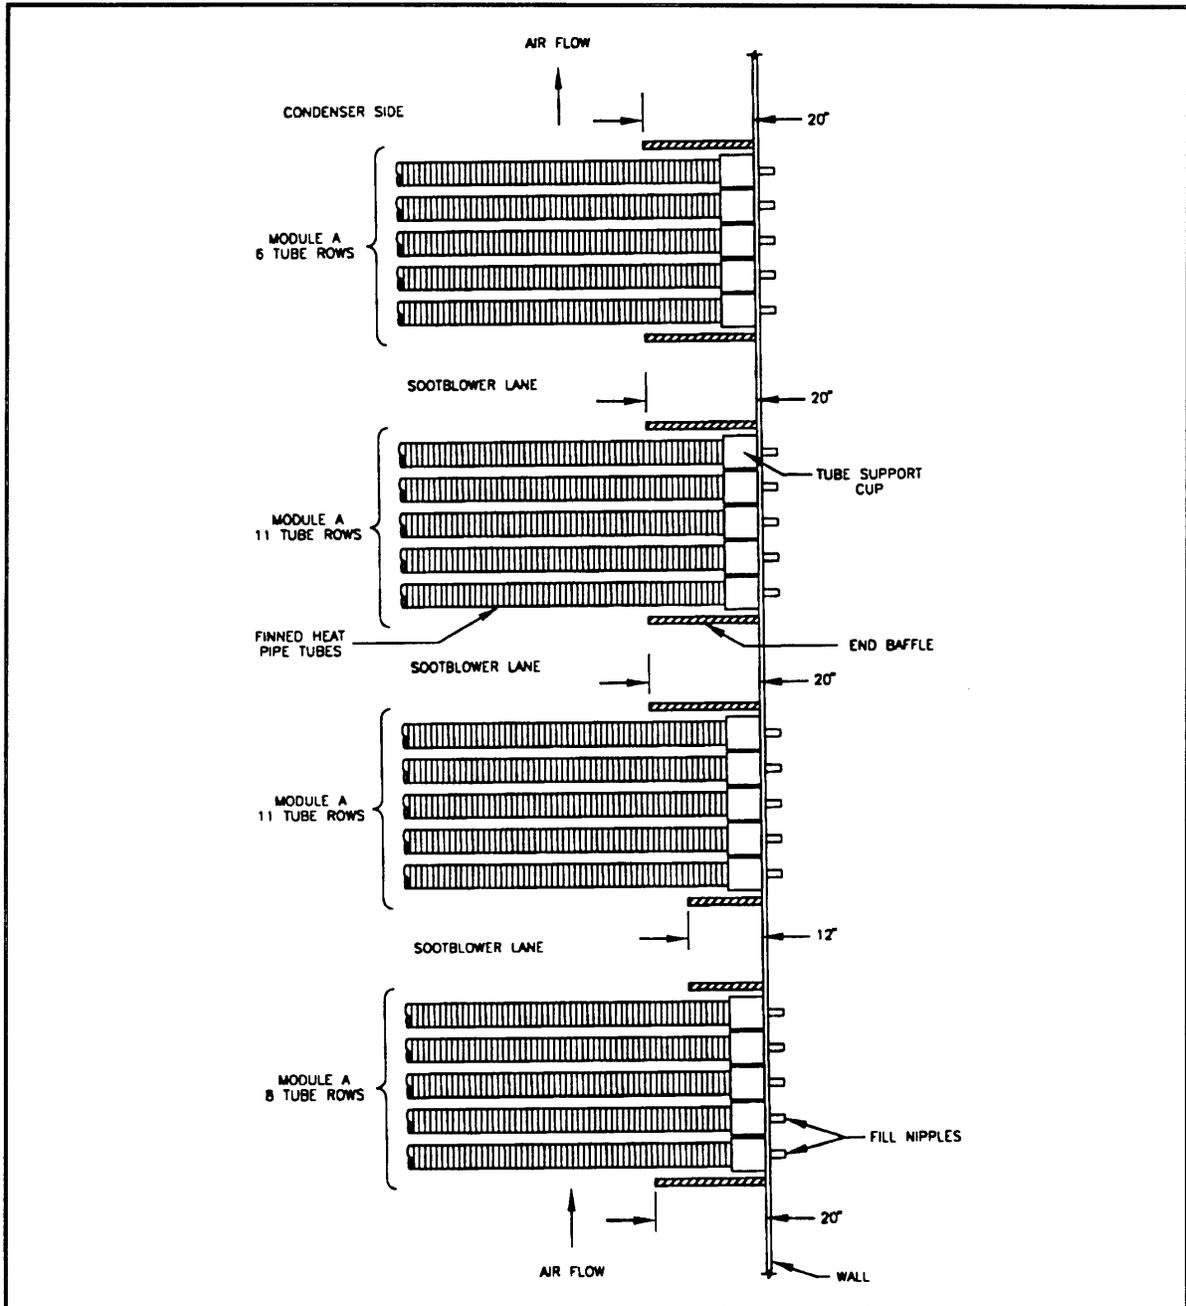
**Figure 19.** Condenser end baffle installation.

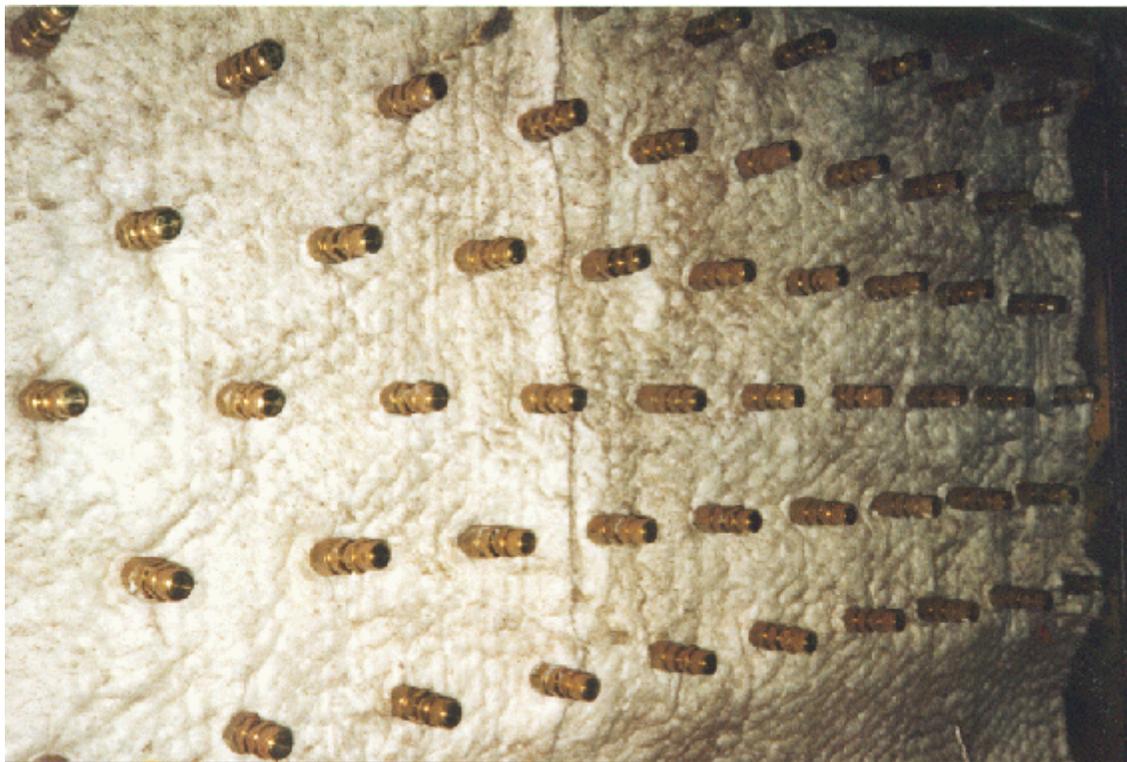
**Figure 20.** Modified fill nipples on heat pipes with naphthalene working fluid.

Figure 20 shows the end of a modified heat pipe tube sheet with the capped fill tube nipple extensions protruding through soft insulation. The insulation covers the fill tube purge valves. Under normal conditions, the tube sheet ends are covered by casing panels. To check for naphthalene leaks, test ports were added to the casing panels. Each port consisted of a capped pipe nipple extending from the casing panel through the external insulation and the corrugated lagging. One test port was installed for each naphthalene module, three ports in the primary sections and four ports in the secondary sections of each heat pipe (refer to Figure 7 for the layout of the naphthalene modules).

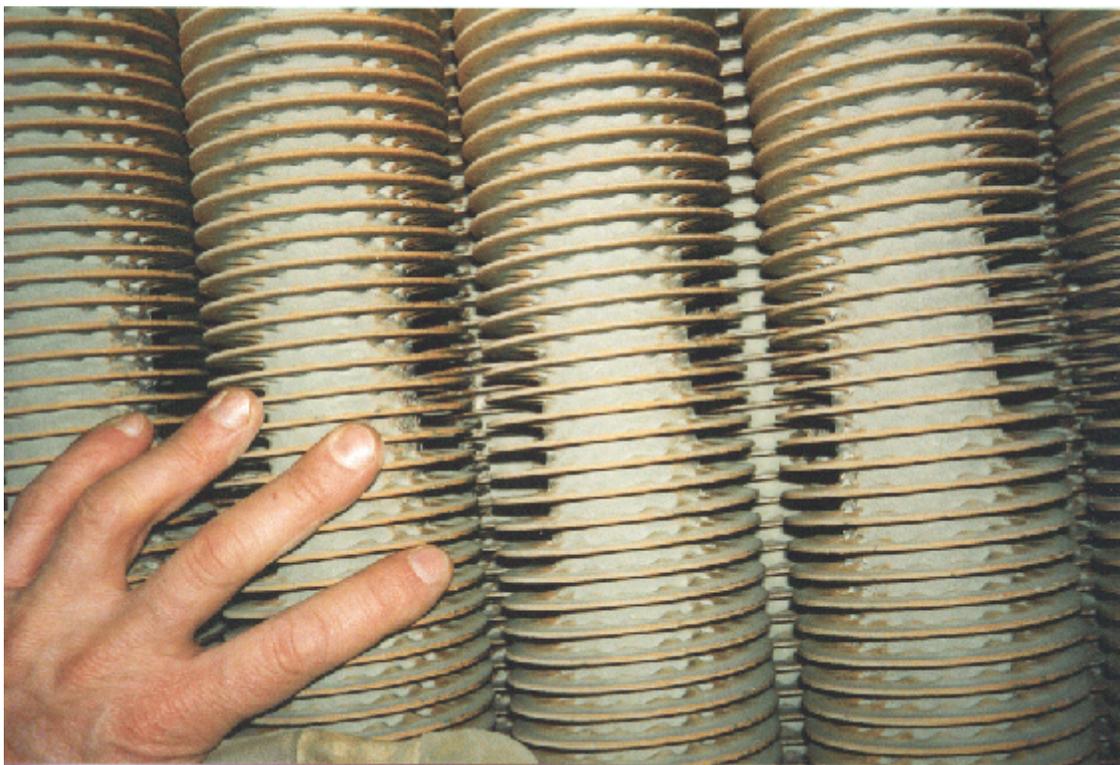
Figure 21. Typical condition of heat pipe tubes in the top three modules.

At Milliken, the heat pipes are washed approximately every six months to remove the cold-end deposits. In all but the cold-end modules, the heat pipes on the flue gas side appear as shown in Figure 21 with tubes and fins free of deposits. Normally, most of the top side of the cold-end tube bank will also be free of deposits. However, in some localized areas, deposition appears as shown in Figure 22 indicating the beginning of the fouling zone. Figure 23 shows the typical condition of the cold-end module as seen from the bottom. Throughout the module, deposition occurs mostly on the top side of the tubes due to the direct impact from the downward flowing flue gases and fly ash. The deposition appears to increase with depth as the flue gases flow through the tube bank and progressively contact colder heat pipes. Figure 24 shows the tube bank after cleaning. When clean, a light, placed below the cold-end module, can be seen (bottom center) through the eight-row deep tube bank.

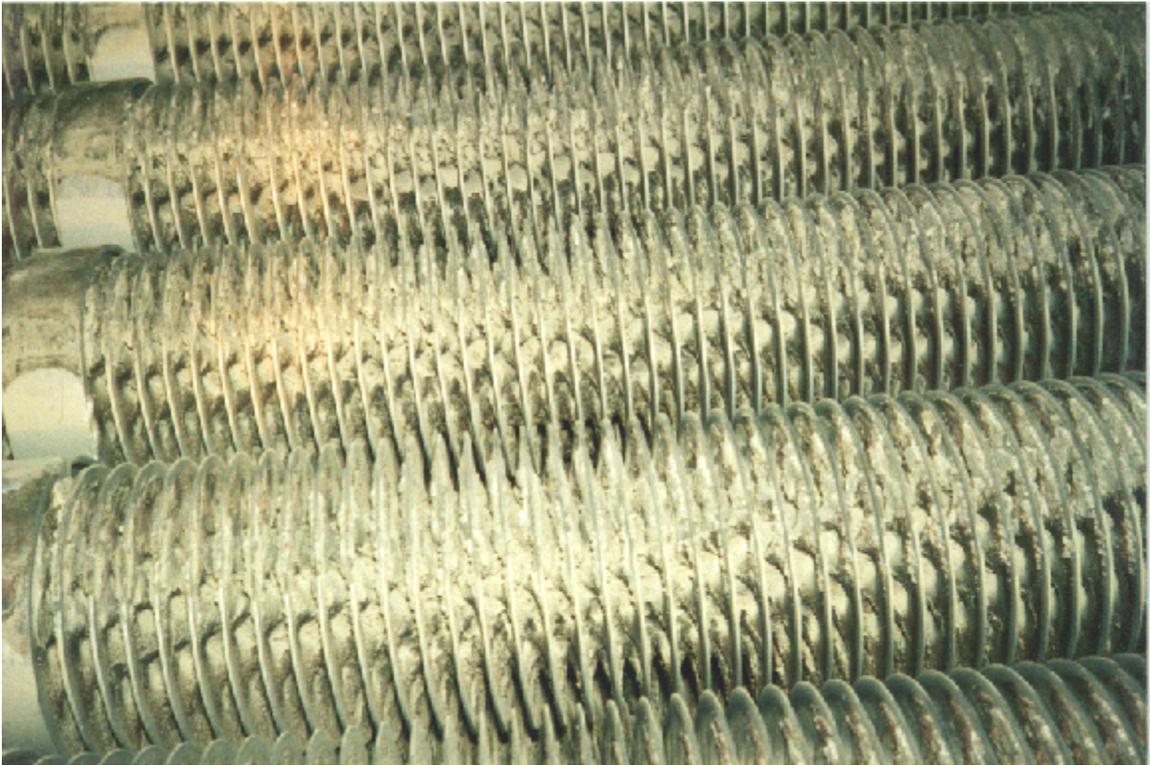
**Figure 22.** Fouled area on inlet flue gas side of the bottom cold-end heat pipe module.

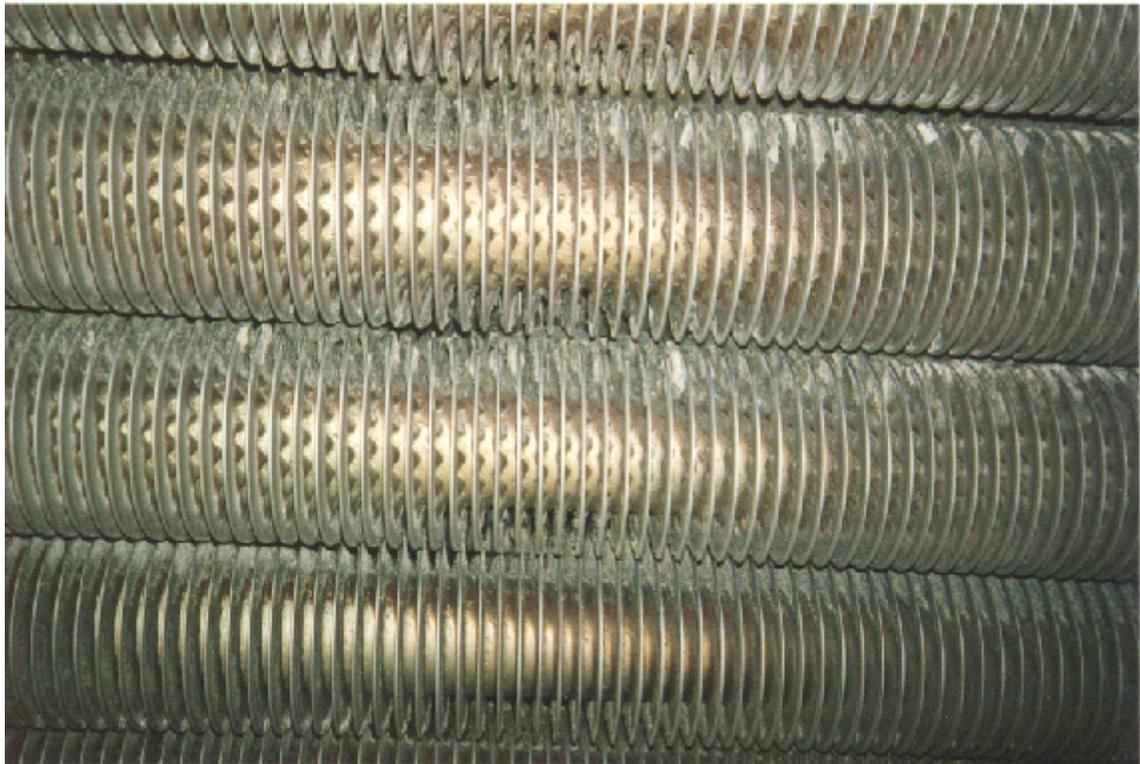
**Figure 23.** Bottom view of cold-end tube bank showing deposits on top side of tubes.

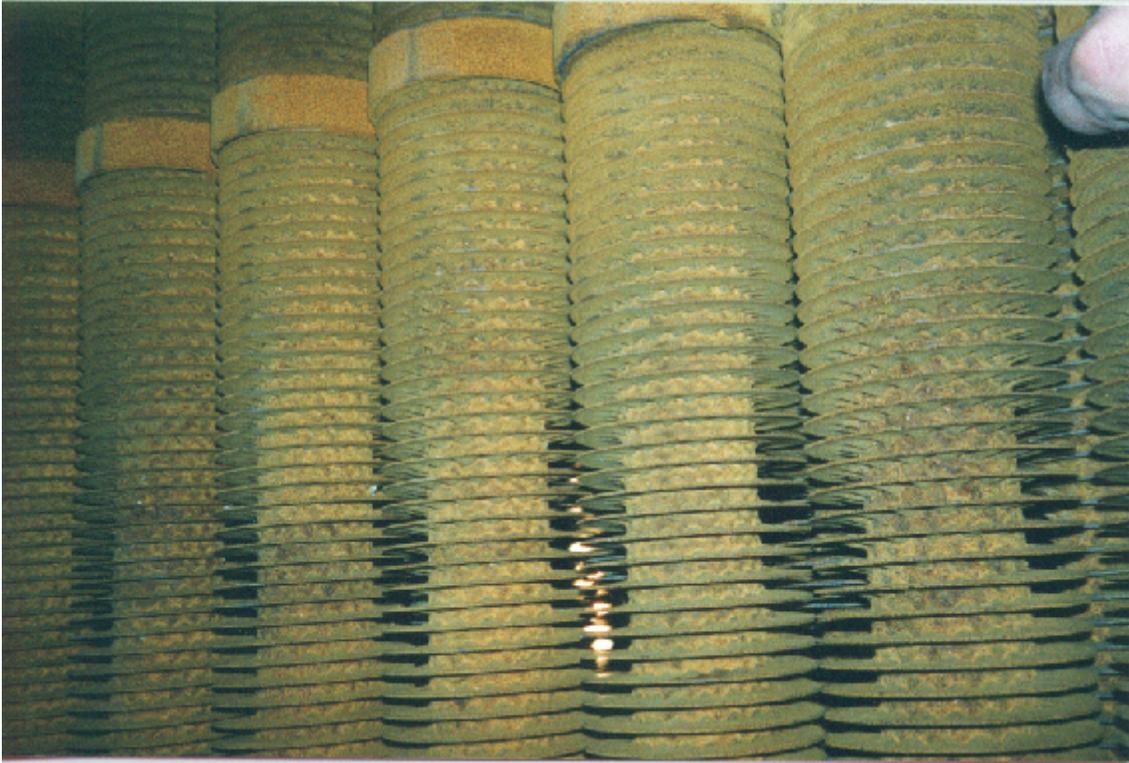
**Figure 24.** Top view of a cold-end tube module after cleaning -- note light showing through tubes.

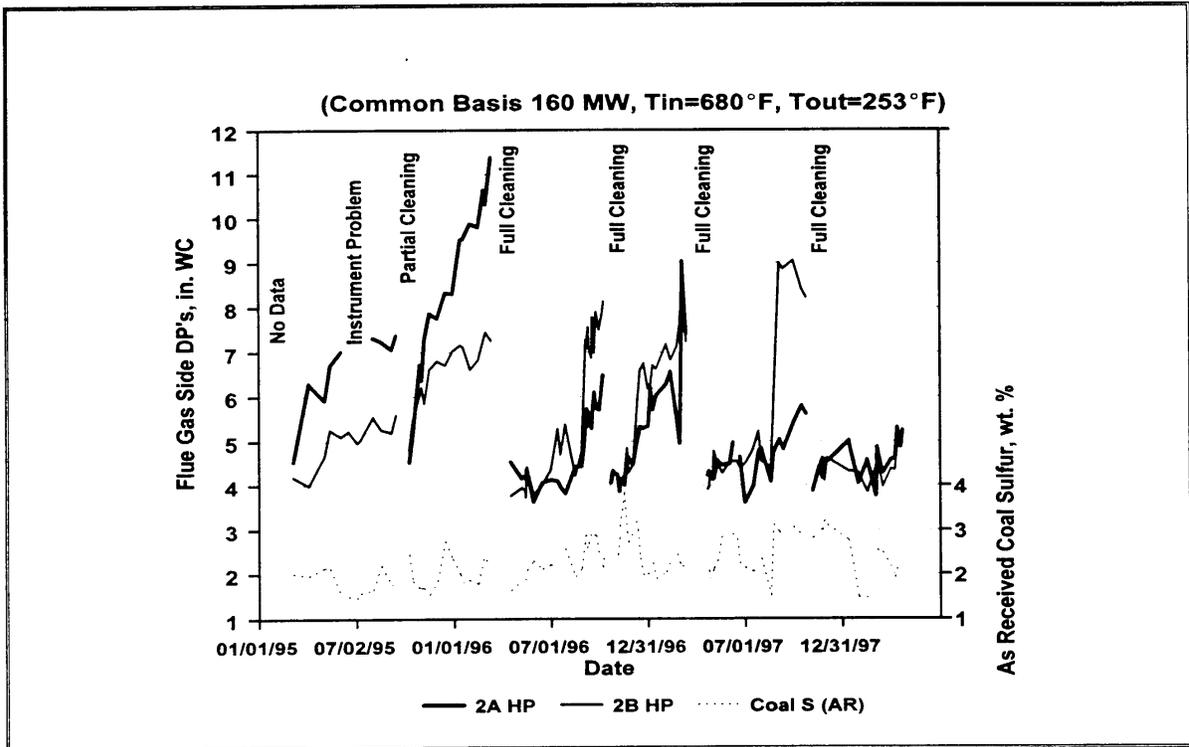
**Figure 25.** Flue gas side pressure drops and coal sulfur level 1995 to 1998.

Increasing flue gas side pressure drop and flue gas outlet temperature are signs of cold-end fouling. Figure 25 shows typical flue gas side pressure drops for the heat pipe air heaters under high load conditions. All pressure drops are corrected to a common basis. Breaks in the plotted data indicate the times when the Unit 2 boiler was off-line for maintenance. During these periods, the heat pipes were washed to remove the cold-end deposits. Figure 25 shows that for one or both heat pipes the flue gas side pressure drops generally increase to high levels in five to six months after cleaning. The figure also shows that the baseline pressure drop of about 4 in. WC is recovered following each full cleaning. Clearly, for the last four wash operations, equivalent cleanliness was achieved for the two heat pipes. The reader may note that the baseline pressure drops are slightly higher (0.1 in. WC - 0.5 in. WC) than the pressure drops reported for the performance tests. This is mostly due to differences in measuring equipment and pressure tap location for the plant process control system versus the special high accuracy taps and instrumentation used for the performance tests. The differences are not significant for the day-to-day system performance monitoring.

For the last operating period shown in Figure 25, the heat pipe pressure drops were better behaved and did not yet show the typical high pressure drop increase. This may be attributable to instituting a practice of not operating the boiler at less than 80 MW load and more attention to balancing heat pipe flows and temperatures. These operating practices help to avoid excessively low cold-end heat pipe temperatures which promote fouling.

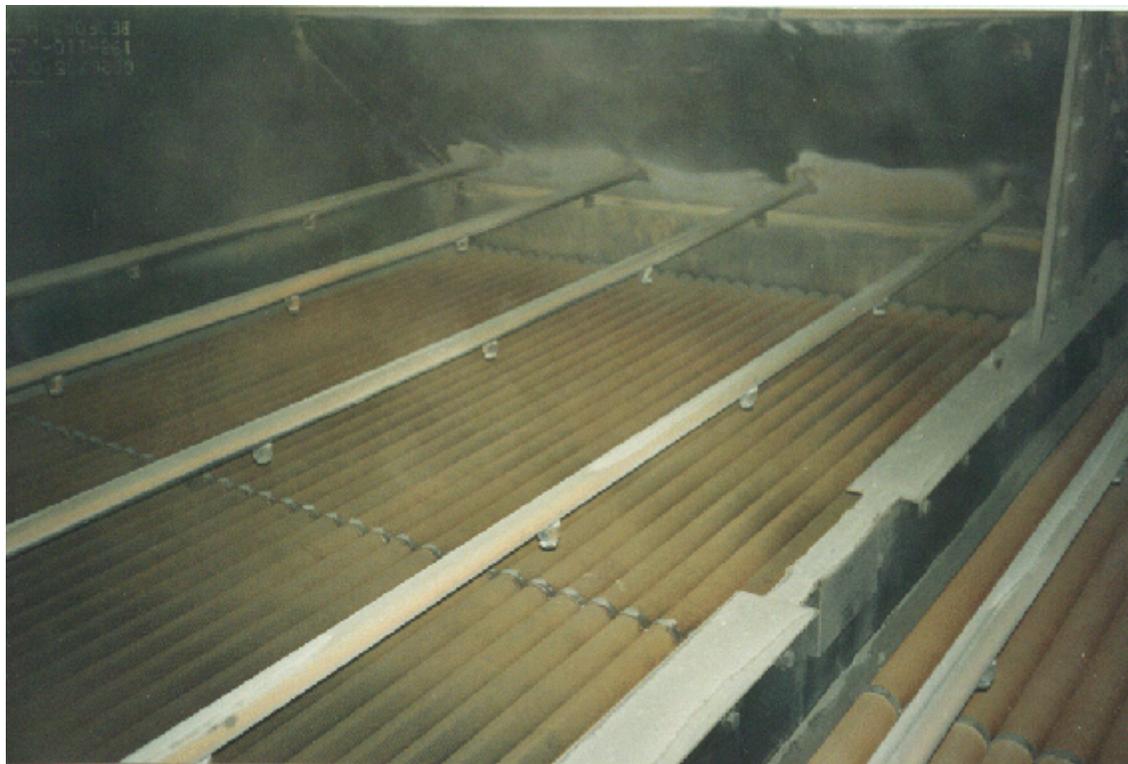
**Figure 26.** Wash pipes above top heat pipe module.

Plugged areas are noted and manually cleaned by water jet using 1/4" tubing lances attached to fire hoses.

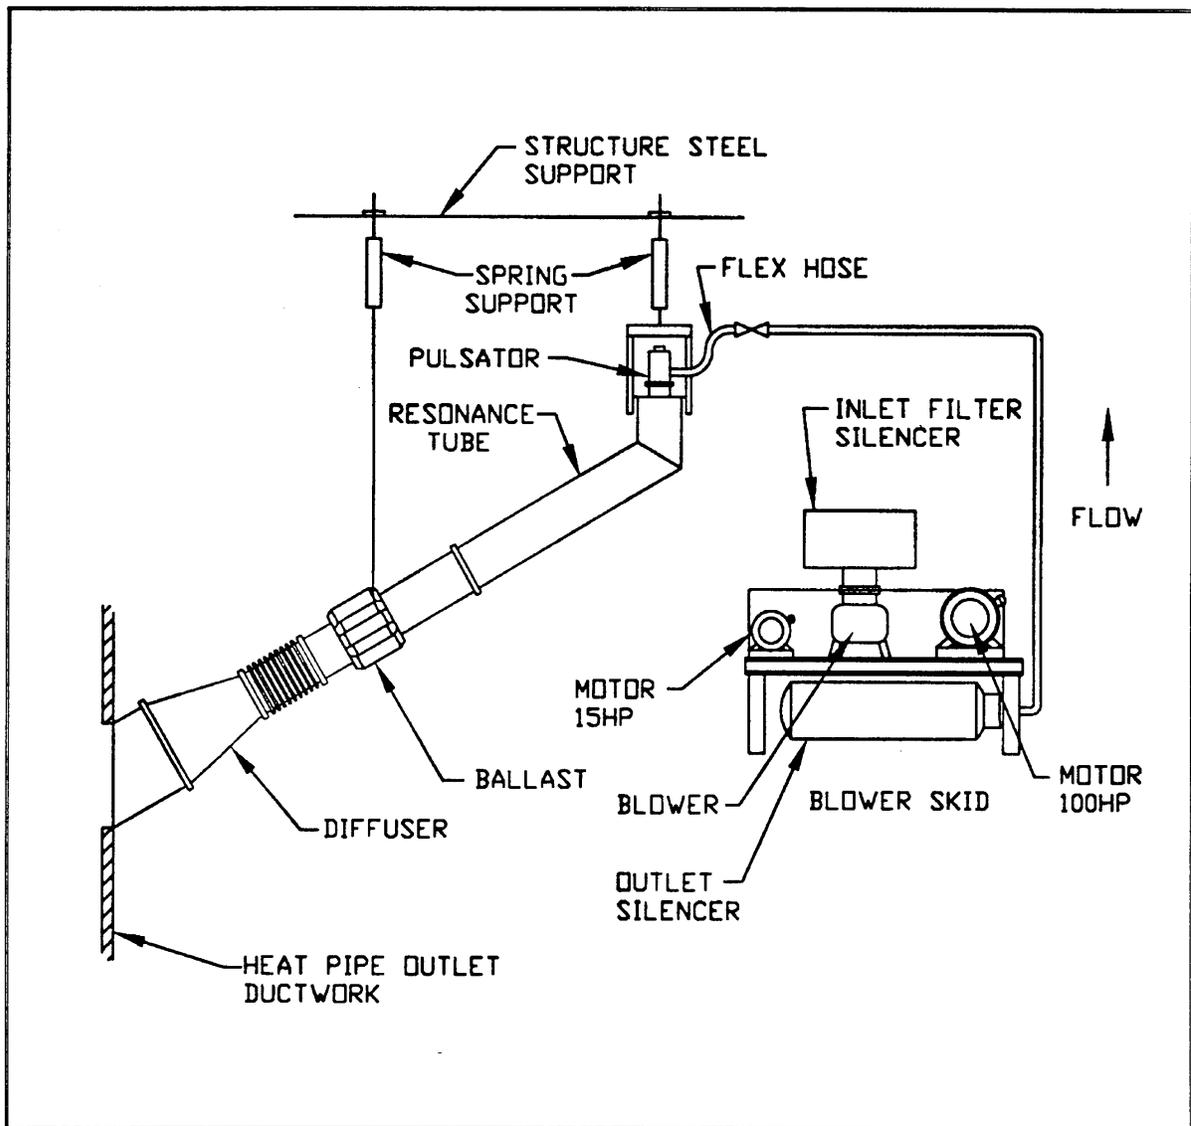
**Figure 27.** General layout of infrasonic cleaner system.

to a ductwork port just blow the cold-end tube banks of the 2A heat pipe. To achieve the highest cleaning benefit, the decision was made to operate the Infracone continuously rather than intermittently. Once the performance was established, the intent was to begin intermittent operation to establish the minimum required cleaning level.

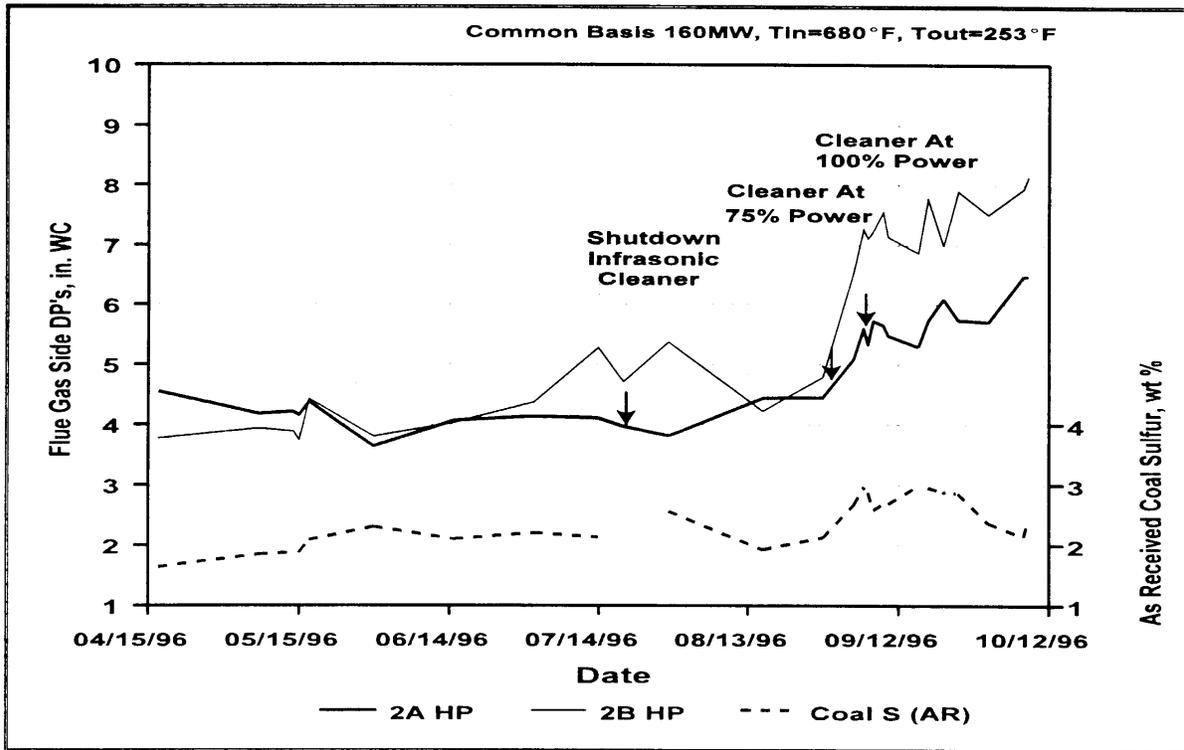
**Figure 28.** Flue gas side pressure drops and coal sulfur during first operation of Infracone™.

Although initial operations of the infrasonic cleaner indicated reduced fouling in the 2A heat pipe, subsequent operations without the cleaner in service indicate that the effect was marginal for the Milliken installation. These conclusions are supported by Figures 25 and 28 which show high boiler load, flue gas-side pressure drops for both heat pipes. Since tube fouling restricts the gas flow in the heat pipes, the flue gas side pressure drops adjusted to a common basis can be used to follow fouling. Figure 28 shows the pressure drop behavior after the Infracone was first placed in service in early April 1996. Between April 17, 1996 to July 19, 1996, there is a slight decline in the 2A heat

pipe pressure drop (4.5 in. WC dropping to 4.0 in. WC), indicating that the cleanliness of the 2A heat pipe was perhaps improving. At the same time, the common basis pressure drop for the 2B heat pipe increased from about 3.8 in. WC to 4.7 in. WC, indicating that the unit was experiencing increased fouling.

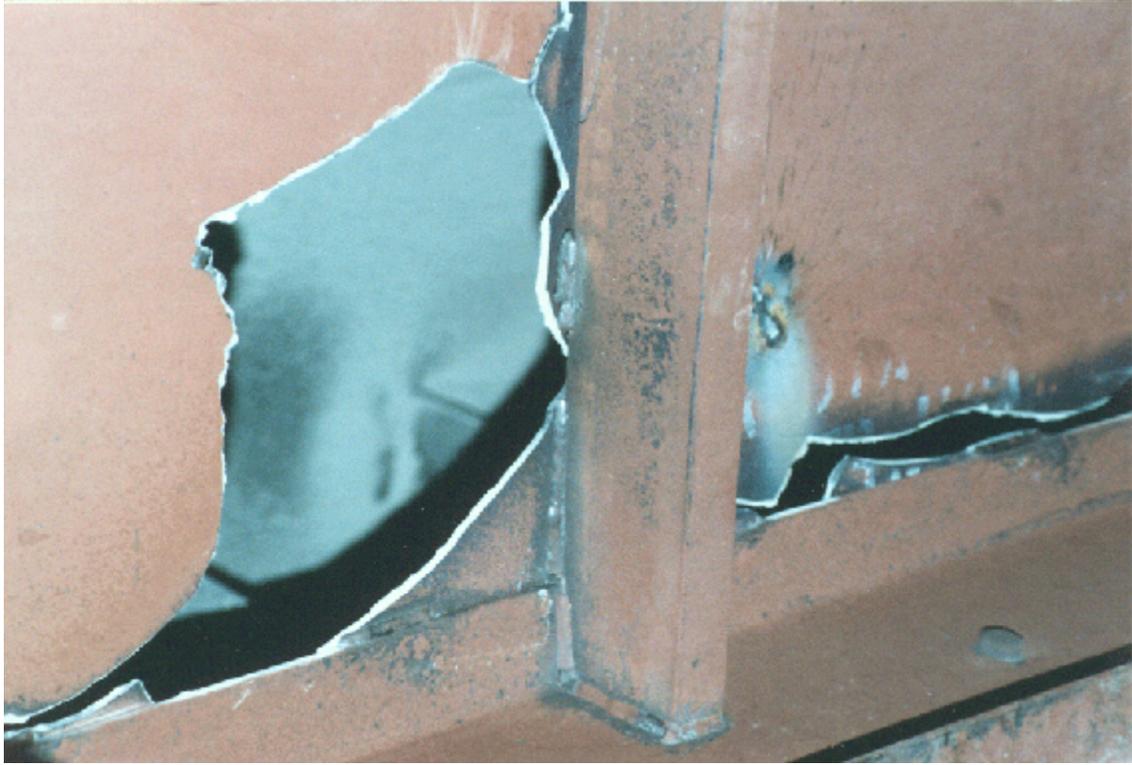
**Figure 29.** Vibration-damaged duct between the 2A heat pipe outlet and the precipitator inlet.

On July 19, 1996 the Infracone was shut down to allow repair of the ductwork between the 2A heat pipe and the particulate collector. Infrasonic resonance vibrations caused metal fatigue which produced cracks and holes in the ductwork. As shown in Figure 28, while the Infracone was out of service, the 2A heat pipe pressure drop increased from 4.0 in. WC to 4.5 in. WC indicating increased fouling. However, for the same period, the 2B heat pipe pressure drop varied somewhat but overall remained essentially constant changing from 4.7 in. WC to 4.8 in. WC; indicating little or no significant fouling. When the Infracone was placed back in service at 75% power, the pressure drops across both heat pipes began to rapidly rise. The renewed operation of the Infracone may have suddenly loosened accumulated deposit and fly ash materials which then blocked flow channels as the materials traveled downward through the cold-end modules. Alternately, the change over of the plant fuel from a 1.8-2.2 wt. % S to a 2.8-3.0 wt.% S coal may have increased acid deposition in the cold-end modules causing the pressure drop rise. Unlike early in the run, operating the Infracone at a 100% power level did not again reduce the pressure drop across the 2A heat pipe. When Unit 2 was shut down in October 1996 after six months of operation, the cold-end fouling in both heat pipes was by visual inspection, essentially the same.

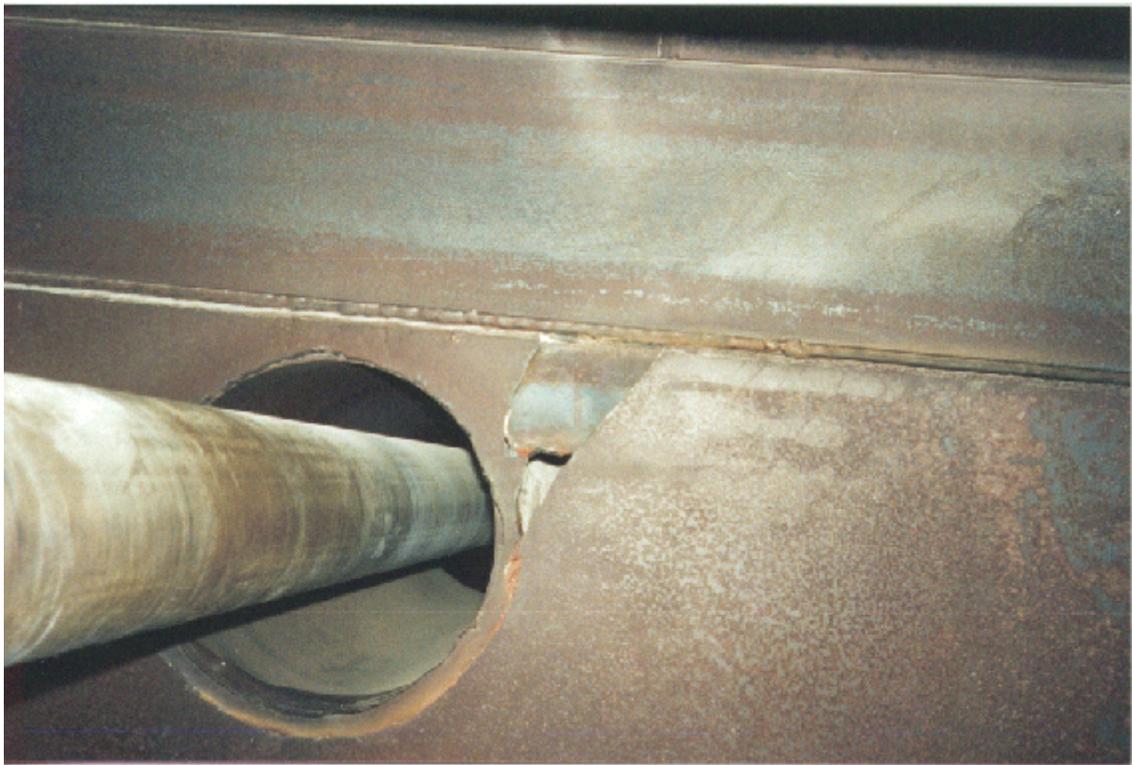
**Figure 30.** Vibration-caused wall cracking in the 2A heat pipe at an internal sootblower lance port.

Figures 30 and 31 show some of the cracking which developed in the primary flue gas/secondary flue gas division walls inside the 2A heat pipe. Figure 32 shows how vibration of the side wall or possibly the finned tube caused 5/8" deep slots to be cut into a gas diversion plate in the 2A heat pipe

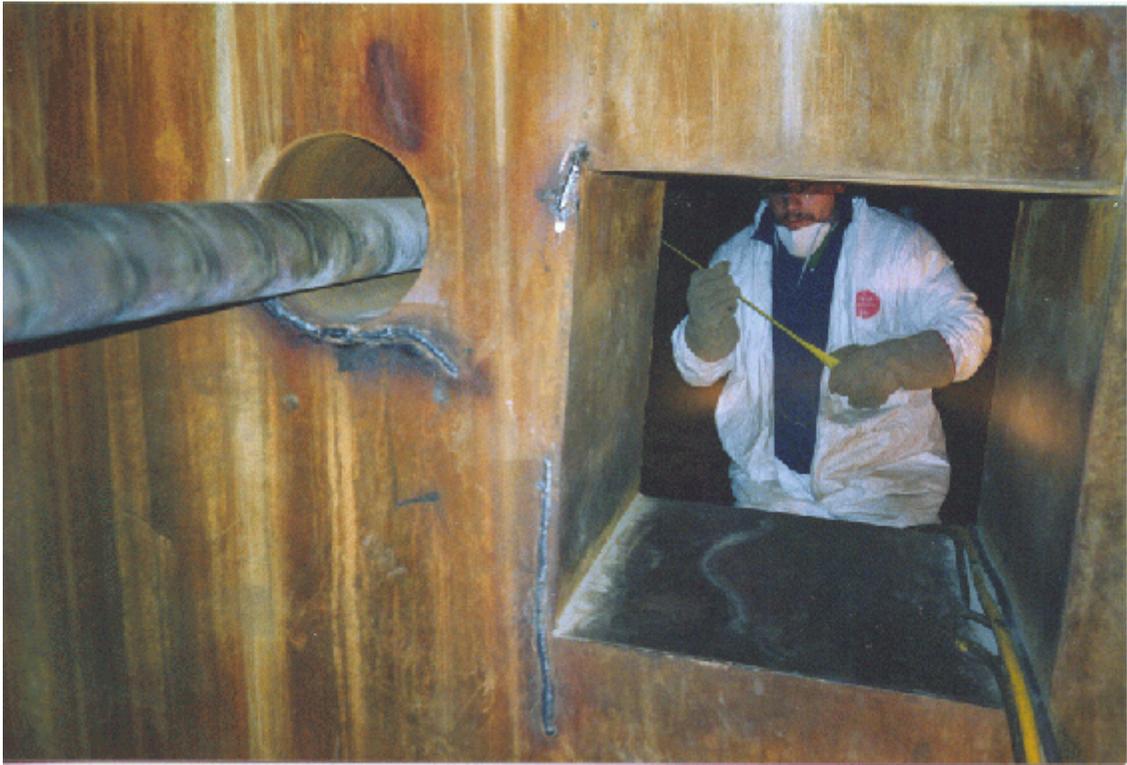
**Figure 31.** Repaired cracks in the primary/secondary flue gas division wall of the 2A heat pipe .

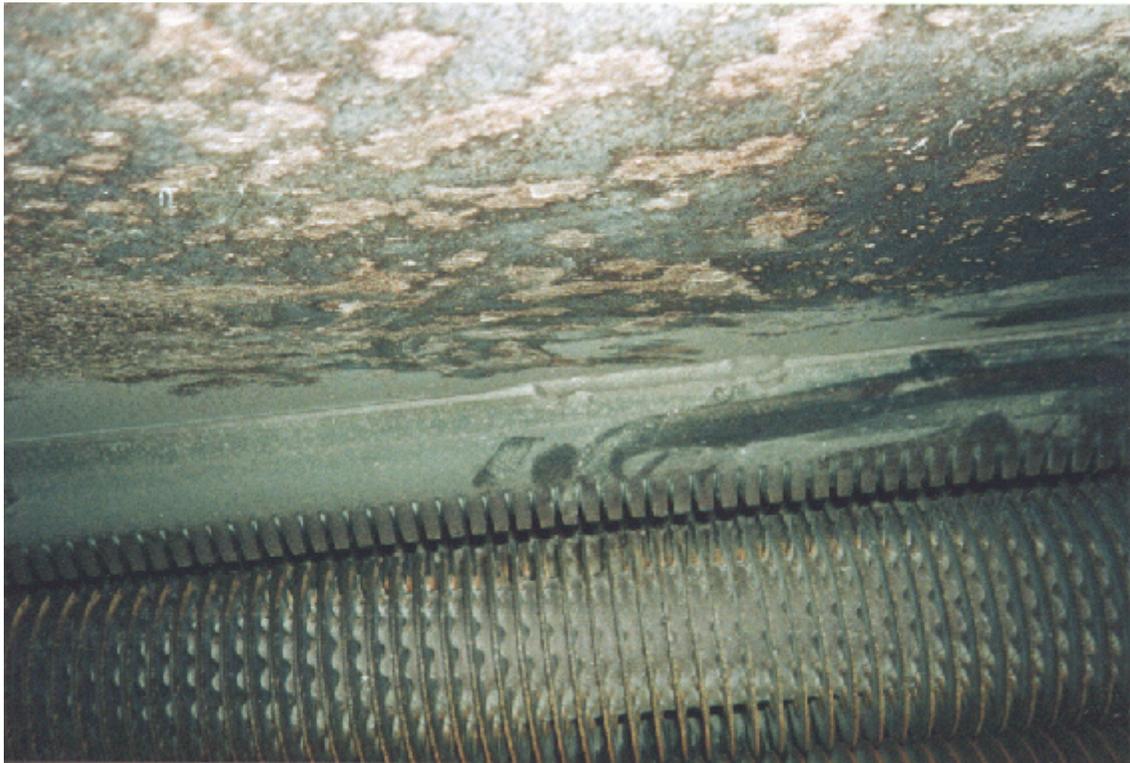
**Figure 32.** Vibration cut slots in gas diversion plate of 2A heat pipe.

cold-end module. After the internal damage was discovered, the decision was made to cease further operation of the infrasonic cleaner.

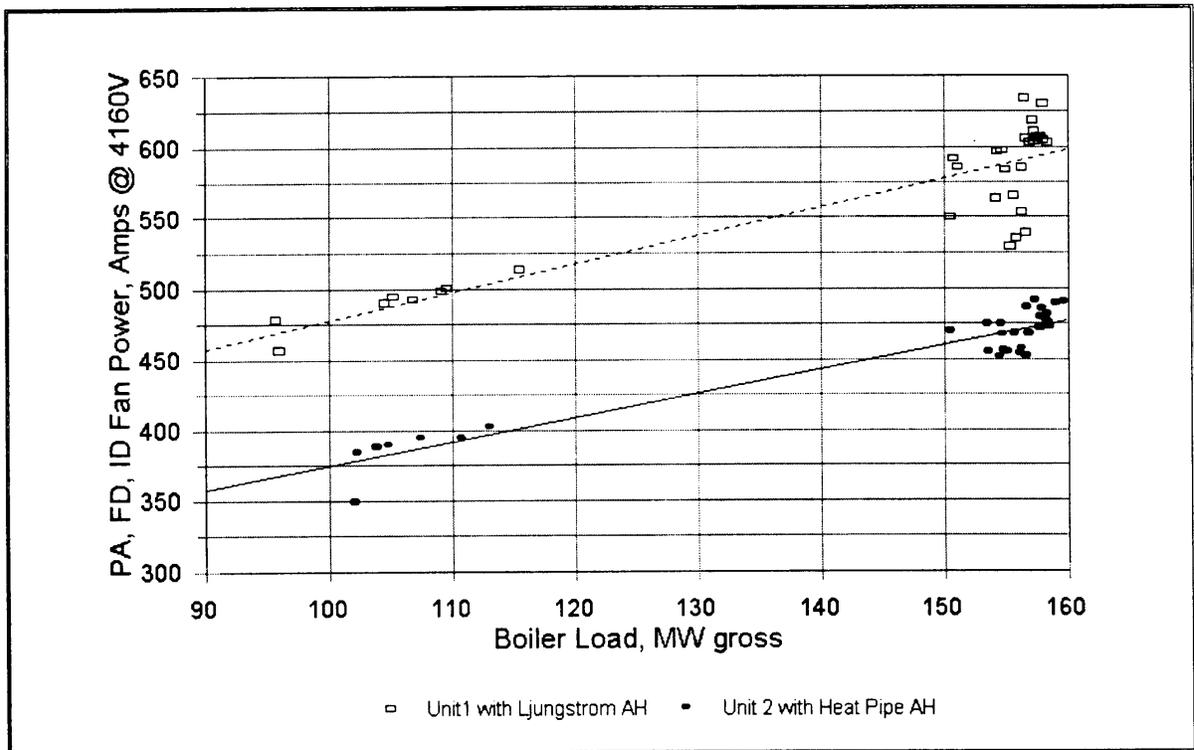
Figure 33. Fan power requirements for Milliken Units 1 & 2.

Figure 33 shows that the Unit 1 fan amperages are significantly higher than the Unit 2 amperages under both low and high boiler load conditions. The differences are approximately 103 amps and 120 amps at boiler gross loads of 100 MW and 160 MW, respectively. Assuming a 0.90 power factor (PF) for the fan motors, the amperage differences are equivalent to 0.67 MW for the 100MW gross load operation and 0.78 MW for the 160 MW gross load operation.<sup>1</sup> These differences represent 0.67% and 0.49% of the low and high load gross power generations, respectively. The results indicate that the use of zero air leak designs, such as provided by the heat pipe air heaters, can provide small but significant performance improvements which can reduce power generation costs.

<sup>1</sup> MW =  $\sqrt{3} \times \text{PF} \times \text{Amps} \times 4160\text{V} / 10^6$

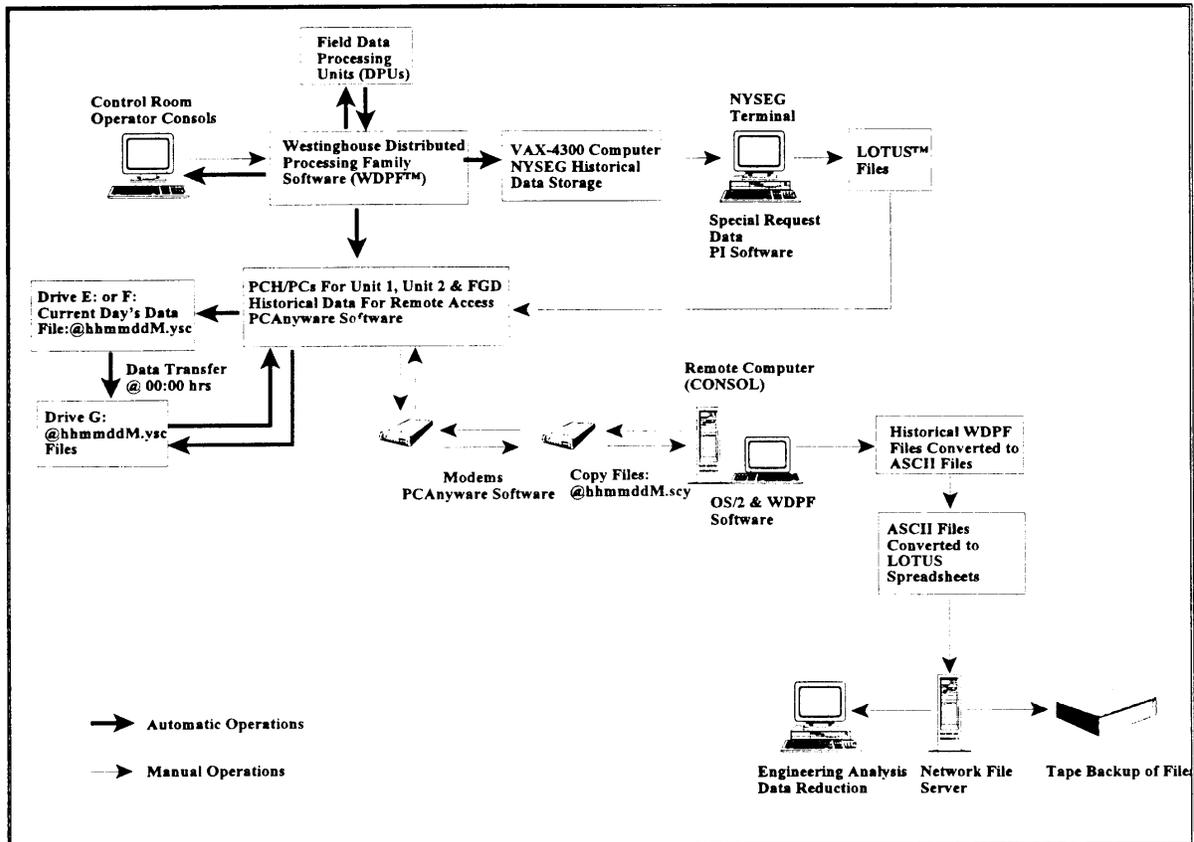
Figure 34. Milliken process control and data acquisition systems.

The WDPF system automatically stores the process operating data on VAX-4300 computers. This provides historical data files and allows plant operators to view trend plots of most process variables. The basic configuration of the monitoring and control system is shown in Figure 34. The figure also shows the set up for remote monitoring which was used by CONSOL R&D to obtain daily operating data for process performance tracking and evaluation. Most of the data used by CONSOL to follow heat pipe performance changes were obtained using the remote monitoring system shown.
